**Flood Control Project Maintenance
Levee Inspections**
LMA District Cover Sheet
Spring 2017 Levee Inspection Results

Sutter Maintenance Yard Maintenance Area 0016

Waterway			Bank	Unit Miles
Unit No. 01 Feather River			Right	4.06
	Spring (March - May)	Summer (June - August)	(September - November) Fall	Winter (December - February)
Unit Maintenance Rating (Fall Only)				
Date of Inspection	3/23/2017 - 3/23/2017			
DWR Inspector	Sterling York			
Accompanied By	Shawn Freitag Sutter Maintenance Yard

Levee Inspection Report By Mile - Spring 2017

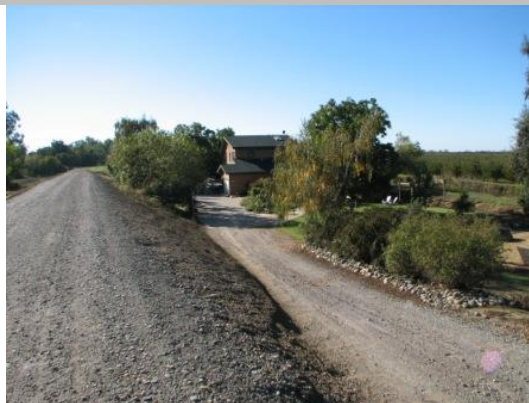
Photo 1 of 1 : SP_2017_MA0016_302_2_20170316_00001.jpg

LM Start	0.06	Rating **	M	Issue No.	2
LM End	0.10	Issue Type +	En	Location *	LS
Category	Earthen Levee			GPS Latitude/Longitude	
				Start	End
Item	Vegetation			39.256618 °	39.257228 °
				-121.636442 °	-121.636462 °
DWR ID	DWR_MA0016_01_s _ 2012_2				
Comment Code					
V6 : Landscaping					
Inspector Comment

This photo shows the landscaping on the landside slope and toe.

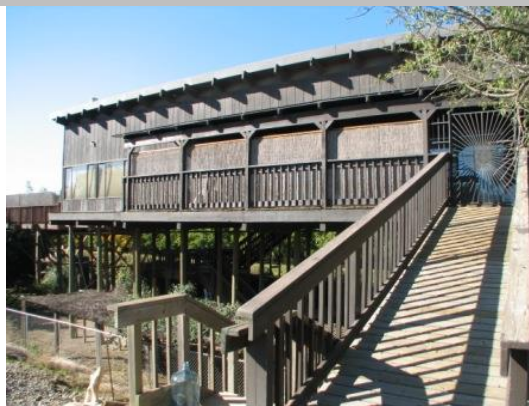
Photo 1 of 1 : SP_2017_MA0016_302_15_20170316_00008.jpg

LM Start	0.18	Rating **	M	Issue No.	15
LM End	0.18	Issue Type +	En	Location *	LS
Category	Earthen Levee			GPS Latitude/Longitude	
				Start	End
Item	Encroachments			39.258437 °	39.258437 °
				-121.636613 °	-121.636613 °
DWR ID	DWR_MA0016_01_s _ 2012_15				
Comment Code					
BU : Building					
Inspector Comment

Levee mile 0.18. This photo shows the building on the landside shoulder and toe.

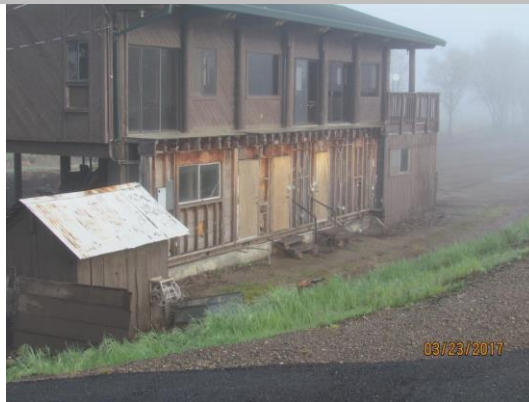
Photo 1 of 2 : SP_2017_MA0016_302_7_20170327_00013.jpg

LM Start	0.44	Rating **	A/W	Issue No.	7
LM End	0.49	Issue Type +	En	Location *	LS
Category	Earthen Levee			GPS Latitude/Longitude	
				Start	End
Item	Encroachments			39.262213 °	39.262825 °
				-121.636545 °	-121.636430 °
DWR ID	DWR_MA0016_01_s _ 2012_7				
Comment Code					
BU : Building					
Inspector Comment					
Landscape & fence has been removed and house is 13' from levee toe.

View of the removed landscaping, fence, and the portion of the house that was encroaching the right-of-way. Spring 2017.

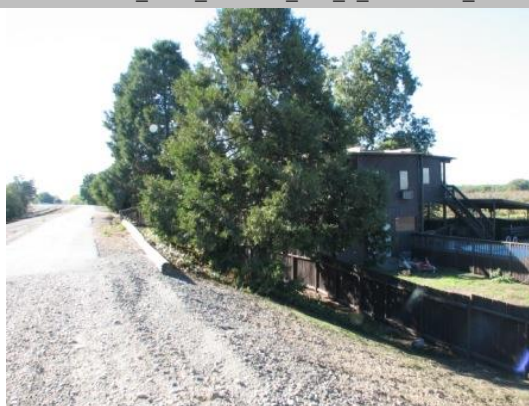
Photo 2 of 2 : SP_2017_MA0016_302_7_20170316_00002.jpg

LM Start	0.44	Rating **	A/W	Issue No.	7 (cont)	
LM End	0.49	Issue Type +	En	Location *	LS	
Category	Earthen Levee			GPS Latitude/Longitude		
				Start		End
Item	Encroachments			39.262213 °		39.262825 °
				-121.636545 °		-121.636430 °
DWR ID	DWR_MA0016_01_s_2012_7					
Comment Code						
BU : Building						
Inspector Comment						
Landscape & fence has been removed and house is 13' from levee toe.

Levee mile 0.49. This photo shows the building and landscaping on the landside slope and toe, Fall 2016.

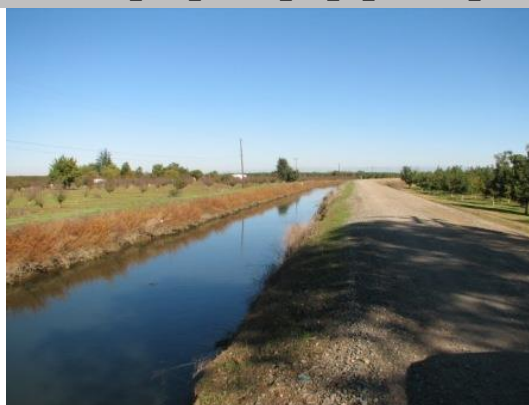
Photo 1 of 1 : SP_2017_MA0016_302_14_20170316_00007.jpg

LM Start	2.85	Rating **	M	Issue No.	14
LM End	3.08	Issue Type +	En	Location *	LS
Category	Earthen Levee			GPS Latitude/Longitude	
				Start	End
Item	Encroachments			39.293675 °	39.296748 °
				-121.636615 °	-121.638192 °
DWR ID	DWR_MA0016_01_s_2012_14				
Comment Code					
DT : Ditch					
Inspector Comment

Agricultural ditch land side slope and toe.

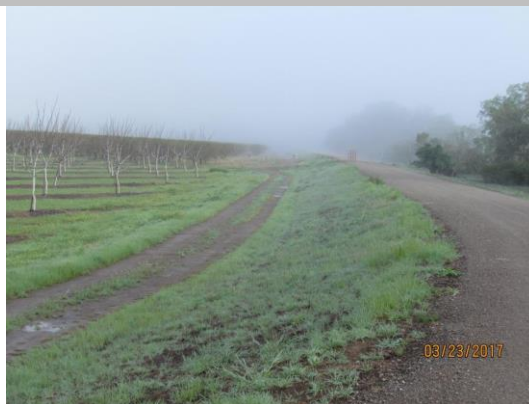
Photo 1 of 1 : SP_2017_MA0016_302_10_20170327_00014.jpg

LM Start	3.19	Rating **	A/W	Issue No.	10
LM End	3.65	Issue Type +	Ma	Location *	LS
Category	Earthen Levee			GPS Latitude/Longitude	
				Start	End
Item	Vegetation			39.298312 °	39.305053 °
				-121.638327 °	-121.637729 °
DWR ID	DWR_MA0016_01_f_2016_10				
Comment Code					
V1 : Control annual grass and weeds on the levee slopes and easements.					
Inspector Comment					
Annual grasses are maintained.

View looking upstream, landside, of annual grasses that are maintained.
Spring 2017.

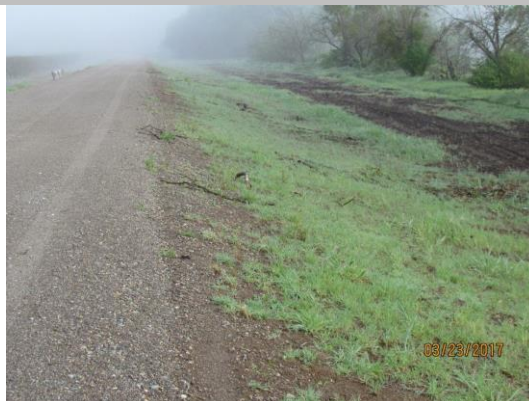
Photo 1 of 1 : SP_2017_MA0016_302_9_20170327_00015.jpg

LM Start	3.19	Rating **	A/W	Issue No.	9
LM End	3.81	Issue Type +	Ma	Location *	WS
Category	Earthen Levee			GPS Latitude/Longitude	
				Start	End
Item	Vegetation			39.298312 °	39.307293 °
				-121.638328 °	-121.637671 °
DWR ID	DWR_MA0016_01_f_2016_9				
Comment Code					
V1 : Control annual grass and weeds on the levee slopes and easements.					
Inspector Comment					
Annual grasses are maintained.

View looking upstream, waterside, of annual grasses that are maintained. Spring 2017.

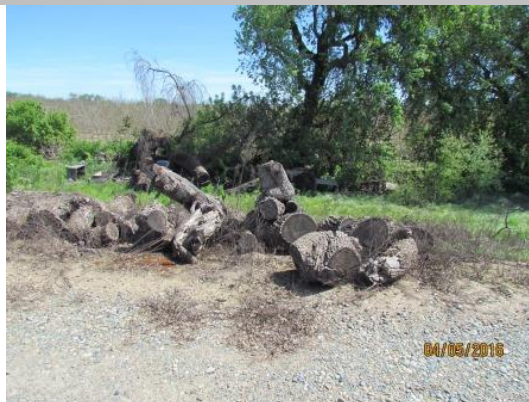
Photo 1 of 1 : SP_2017_MA0016_302_11_20170316_00006.jpg

LM Start	3.27	Rating **	M	Issue No.	11
LM End	3.27	Issue Type +	En	Location *	WS
Category	Earthen Levee			GPS Latitude/Longitude	
				Start	End
Item	Encroachments			39.299502 °	39.299502 °
				-121.638326 °	-121.638326 °
DWR ID	DWR_MA0016_01_s_2016_11				
Comment Code					
PR : Prunings					
Inspector Comment					
Logs still on levee crown, waterside, as of 2016 fall inspection.

Large pruning on waterside slope.

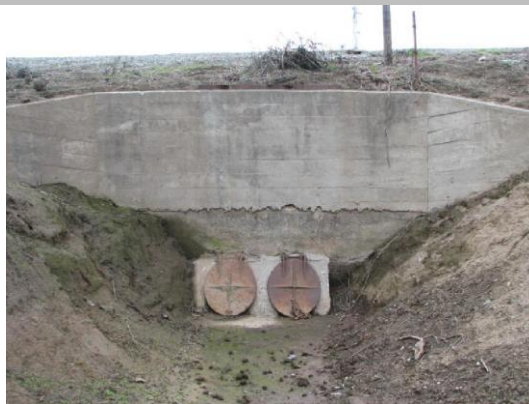
Photo 2 of 2 : UCIP_SP_2017_51157_65781.jpg

Headwall on WS toe with flap gates.

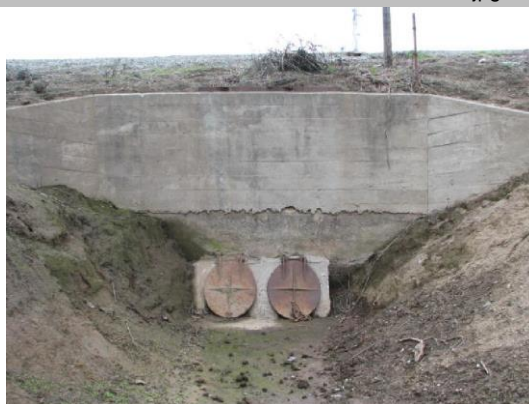
Photo 2 of 2 : UCIP_SP_2017_51158_65779.jpg

Headwall and flap gate on WS toe.
